**NH Preservation Alliance
Historic Barn Assessment Grant Program**

Houston Barn

Houston Drive, Contoocook, NH

August 2021

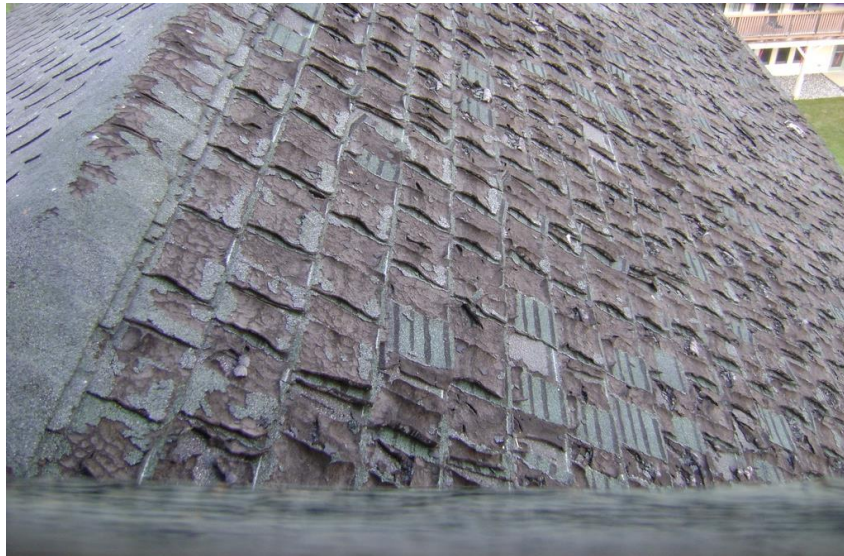
Barns live or die by their roofs. Vast numbers have been forever lost from this factor alone. Fortunately, the Houston barn was re-roofed in recent memory and this undoubtedly saved it. Unfortunately, as with many other buildings in recent decades, it has suffered the catastrophic premature failure of the asphalt shingles used. They are in very poor condition, especially on the west side. The east side is not as bad yet, but sure to follow.

Photo #4 - Roof shingles in extreme failure, west side.

The roofing shingles are in extreme failure and the barn should be re-roofed as an urgent priority.

A painted/galvanized metal roof seems likely to be more reliable for the long run. Screw-down ribbed panels are simple, good value, and have demonstrated a long life span. They are visually rustic but appropriate for agricultural buildings. Site-formed "standing seam" metal roofing is perhaps more elegant but is also more expensive. Specialty products such as genuine or faux slate could be considered. In all these examples it should be noted that snow and ice build-ups may drop precipitously, and snow guards (and ground-level snow removal needs) should be considered, especially if the basement doors are to be used in winter.

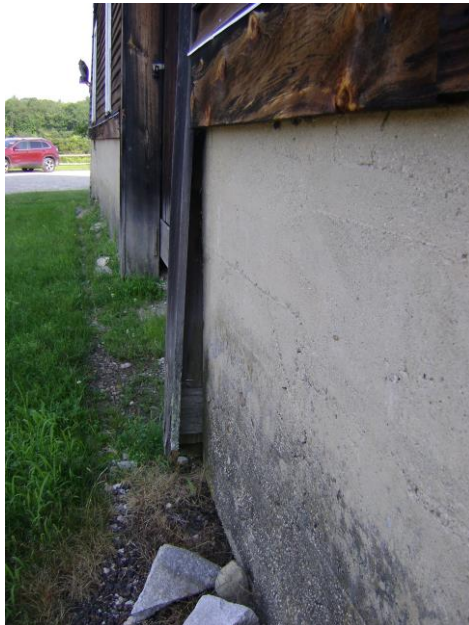
The stem-wall on the west side, however, does have more visible issues. Although the barn's elevations remain true, and no overall settling is evident, cracking and distortion of the (un-reinforced?) concrete is readily visible, especially at its north end. Also the several individual sections of concrete show some tilting outward to the west, and a departure from plumb by several inches as seen compared to the vertical wood trim-work.

Photo #5 – West foundation, concrete stem-walls leaning out at top.

This lean would seem to reduce and threaten its load-bearing capacity, although no larger harm is yet apparent. At the exterior base of the stem-wall sections, it seems various past efforts have been made to arrest the tilting, with fieldstone rubble, and/or concrete buttressing being added. It seems likely this was to counter the effects of water falling along this wall from the roof, and destabilizing the footings (if any).

It is possible that the tilted western concrete knee-wall is currently stable, but it should be evaluated and monitored. Possible replacement with modern foundation and footing, including appropriate drainage, could be considered.

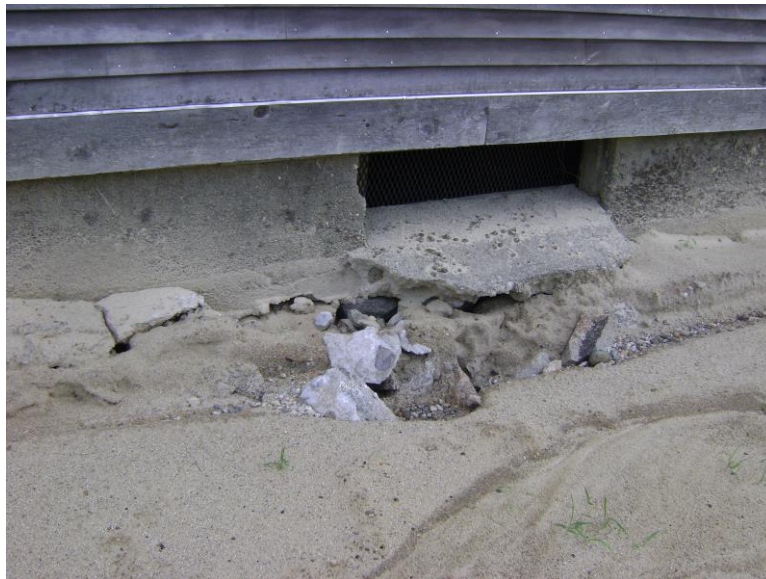
Significantly, water is also definitely a clear and present hazard on the east side. A combination of surface drainage, and large quantities of runoff from the barn roof, is eroding the fine sand fill against the eastern foundation.

Photo #6 - East foundation, water infiltration and soil erosion.

Seepage through the granite foundation wall is carrying away the subsoil, and conversely depositing it as large amounts of silt on the basement floor.

Moreover if (when) the wet subsoil freezes in winter it can expand and exert enormous pressure on the foundation, distorting it westward. Signs of this seem to be visible. This would have been less likely when the barn was in use and the foundation "insulated" with manure

The eastern side of the barn should have definitive attention paid to correcting the drainage issues. The existing fine sand fill is aggravating the situation, eroding, and being transported easily. This would likely require significant excavation and drainage measures, and re-contouring of surface grades, to include diverting both rainfall from the roof and flowing surface water. Also effective removal of sub-surface groundwater should be addressed, which will also mitigate any frost-expansion forces. Uncorrected, the long-term destabilization of the east foundation wall is possible, even likely.

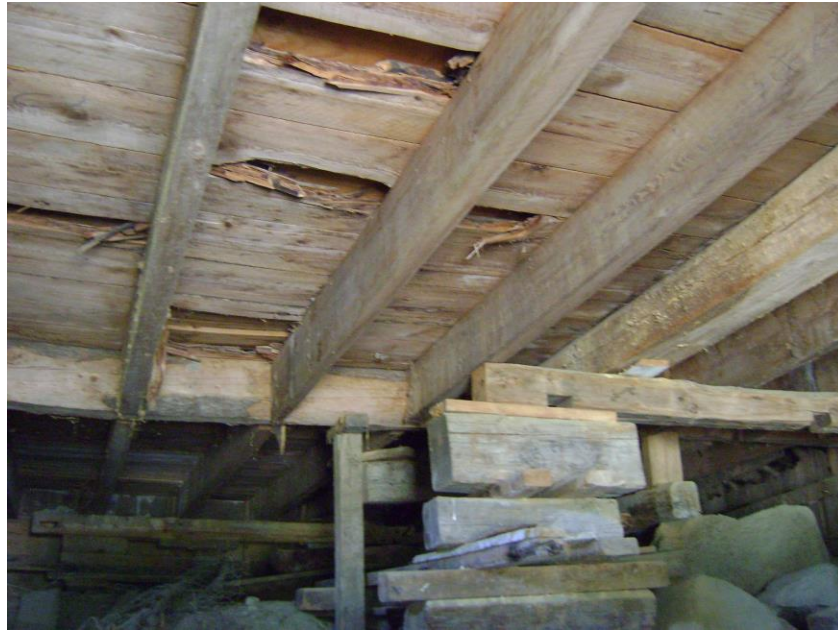
The main aisle floor (center "drive") and its major supporting beams are decayed in the first bays inside the large doors at both north and south ends of the barn, perhaps from snow and water entering at the open doorways over many years. Past partial repairs are visible, and ad-hoc cribbing and posts have been installed to support decayed or spliced beams.

Photo #7 - Northwest section of undercarriage, damage to floor and sub-floor framing, temporary cribbing.

These repairs are less than optimum and are themselves deteriorating. Examples are areas beneath posts 1C, 2C, 3C and near the basement stairway below posts 8B, 9B. (Refer to previous SFC Engineering Partnership Inc. report's first floor framing plan.) This includes important structural floor beams, but would be relatively straightforward to repair.

The damaged interior floor carrying-beams, joists, and flooring over the basement should be opened up from the main floor and fully replaced in the areas needed - especially northern and southernmost bays of the main drive. New heavy timber beams and load-bearing structural connections should replace the jury-rig posts and cribs. As this is done, corrected (level) elevations can be restored throughout by jacking in areas where frame members may have settled.

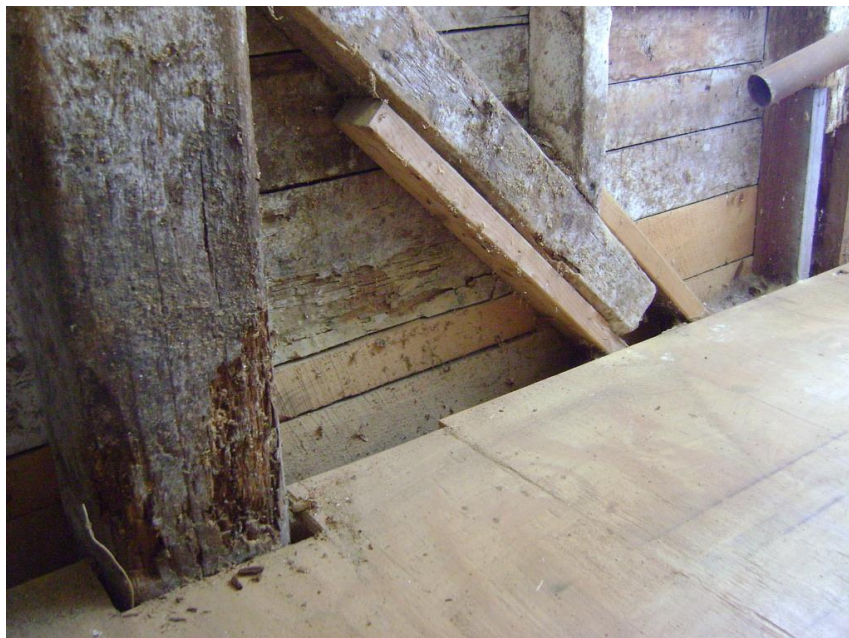
It was observed in some areas of the east wall interior, in the cattle tie-up area, that past decay has occurred at wall post feet and their knee type "up braces," likely from the effects of animal wastes.

Photo #8 - Repairs indicating possible decay at sills from animal wastes.

Past repairs have been made, but wall paneling, plywood floor overlay, and stored items made full assessment for this report impossible. The sill(s) beneath may or may not also be involved.

The sill area and post feet of east wall tie-ups should be exposed and evaluated for rot caused by animal waste. Logically the same may be true for the west wall sills and posts, although it was not possible to view them. However, a small amount of superficial decay need not condemn a large sill timber that is well supported on the foundation.

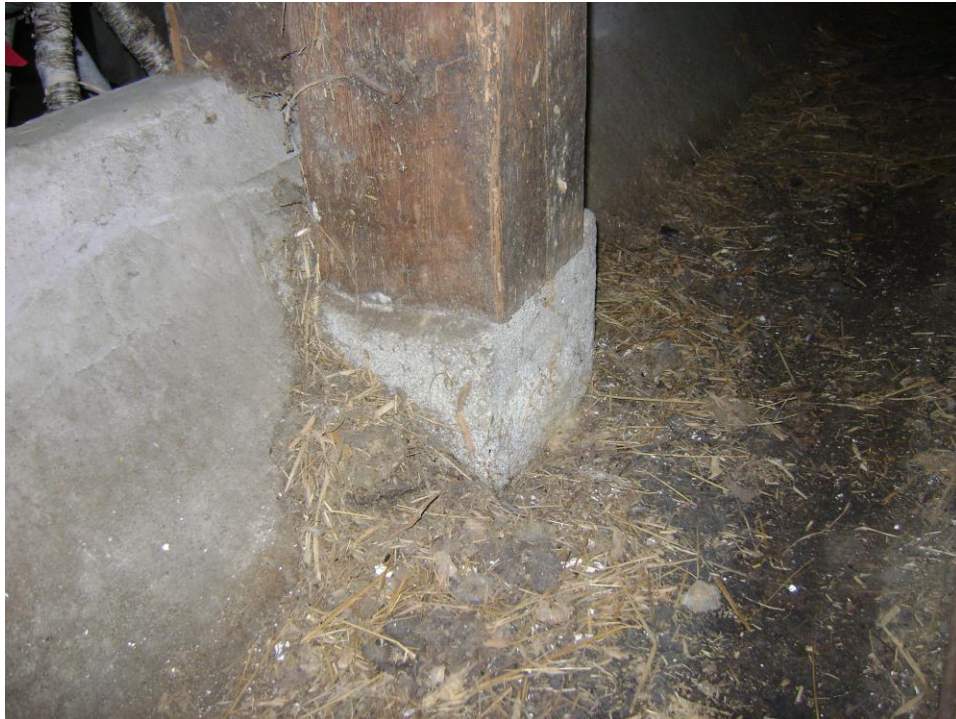
On the main floor, massive concrete feed troughs (bunks) were retro-fitted by cutting off the feet of the primary timber posts on each side of the main drive. These fore-shortened posts now sit supported upon cast concrete steps.

Photo #9 - Concrete feed trough with step for shortened primary post. (Typical)

Two concerns arise. Firstly, concrete can conduct moisture into the wood, engendering decay or insect infestation, and indeed powder post beetles appear to be active at a number of these locations. Secondly, if it is contemplated to ever remove the concrete bunks, the posts will need extending or other supporting measures installed to fill the gap and maintain the load-path to the basement posts below.

The post feet on the concrete feed troughs should be treated to arrest insect damage. If the concrete is to be removed, the posts can have base extensions spliced into them, or supporting plinths constructed, to maintain their correct elevation and carry their full loads.

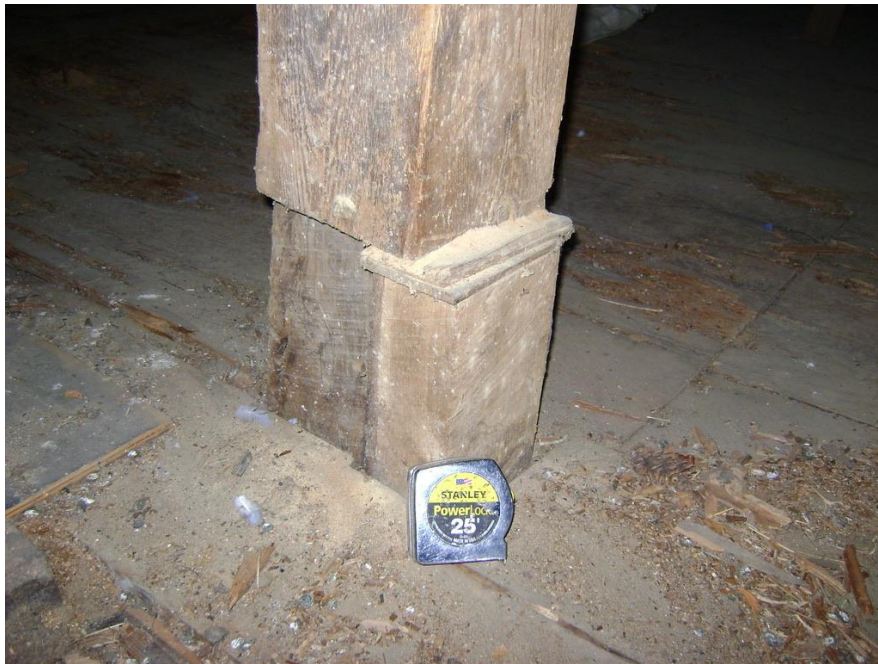
In the remaining area not perched on concrete (at the northwest of the main drive) there has been a shortening and downward displacement of the major post(s), centered in the area of Posts 2C, 3C. This may have been rot resulting from a roof leak in the past, accumulating in hay or bedding materials. A decayed section of the 3C Post foot has been sawed off and blocked up, but inadequately. Again insect damage seems to be active at that location.

Photo #10 - Post 3C, cut off and shimmed, also active insect boreholes and frass evident.

Post 3C and its neighborhood requires prompt attention, in conjunction with associated repairs at the basement level and the joinery at attic level. This would include jacking to restore correct elevation and load bearing, with strong splices and/or plinths to restore their bases as necessary. In that process the 3C attic Queen-post tenon should be drawn back into original position, and permanently secured. A solid continuous load-path from roof to basement footings must be re-established.

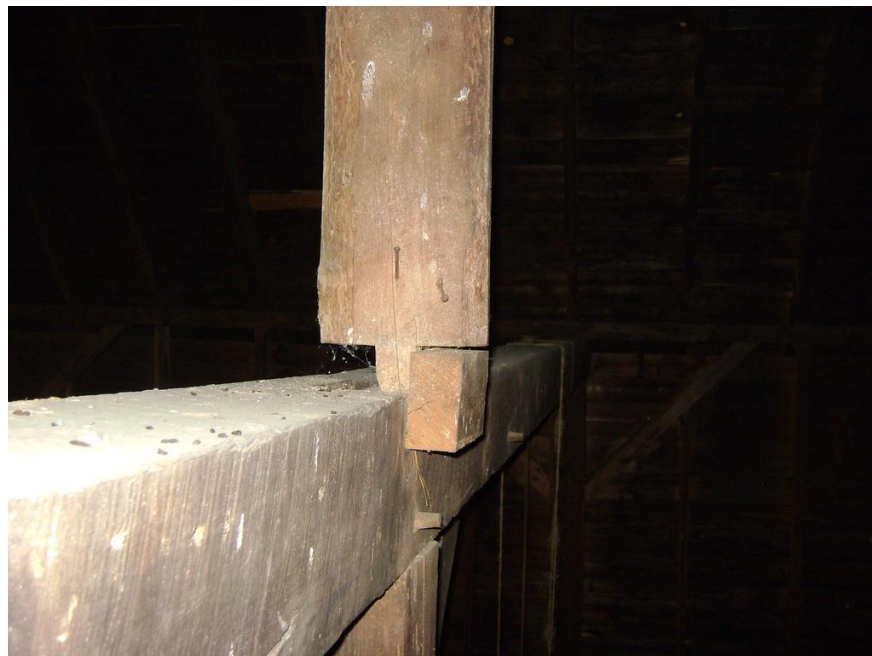
Importantly, at the attic loft level, it can be observed that the same Post 3C has sunk enough (3") to detach the higher queenpost's foot tenon from its mortise in the tie-beam and allow the tie-beam itself to sag notably.

Photo #11 - Displaced tenon at tie beam above post 3C. Vital roof support is potentially compromised.

A scab block has been nailed to restrain the tenon but that is inadequate for such a critical connection - one that carries the load of the roof. If it fully detached, the roof area above could be at risk of partial collapse.

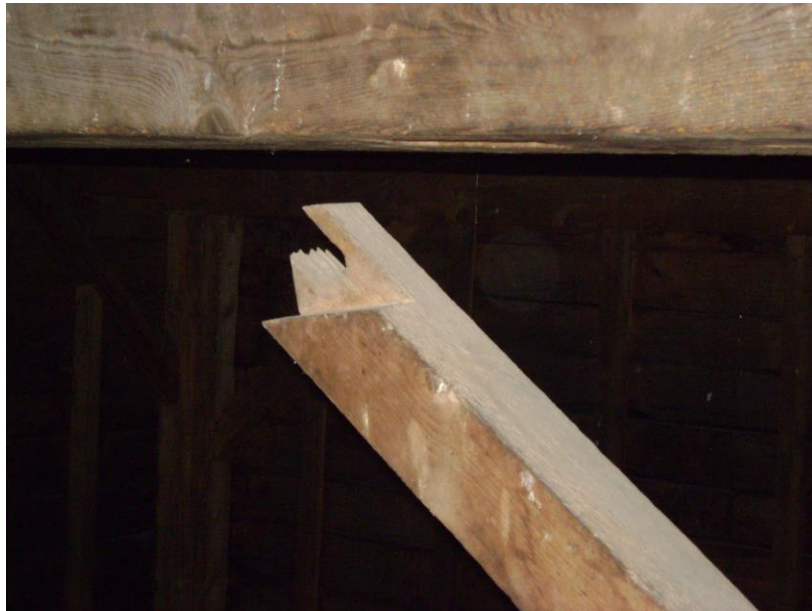
Even ignoring that worst-case scenario, uneven post elevations induce unhealthy tensions and stresses on a frame. That slumping or sagging has the secondary effect of inducing some lean in other posts. The frame though-out is strengthened by knee braces mortised into the major timbers, and some are displaced or missing as a result of the main posts settling unevenly. This weakens the frame resistance against wind loads, etcetera.

Photo #12 - Disconnected knee-brace, indication of settling and distortion of major frame timbers such as Post 3C.

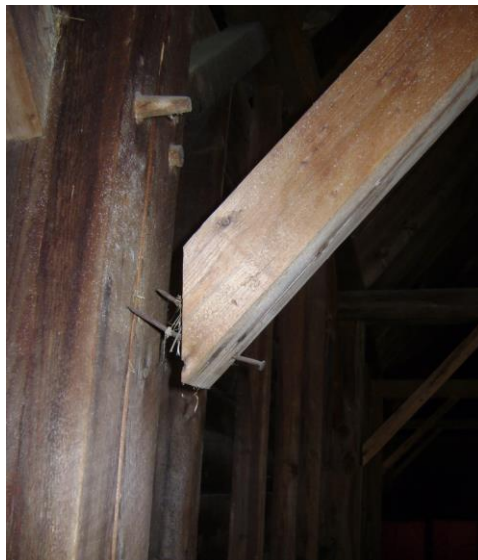
Also, for reasons possibly associated with the necessary sequence of operations during the original barn-raising, the knees from tie beams to wall posts are not mortised at their heels, but only nailed. A number of these points are loosened or detached.

Photo #13 - Nailed knee-brace connection at wall post separated. (Typical)

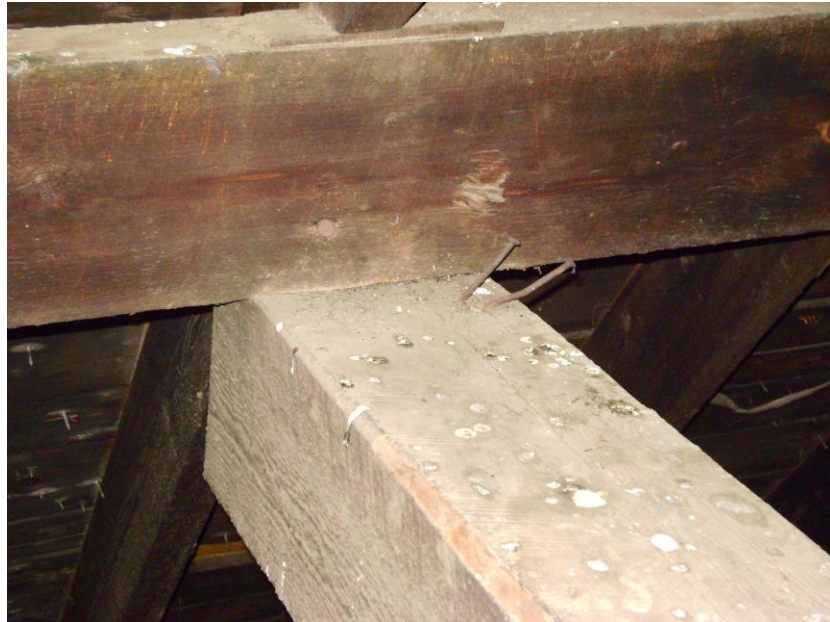
While considering windstorms, it can also be noted that the structural purlin beams, supporting the rafters at the break angle of the roof, are connected to their cantilevered horizontal support beams only by gravity and a very few toe-nails.

Photo #14 - Structural major roof purlin attached to bent by toe-nails only.

Obviously this has sufficed well enough for over a century - but perhaps does not take into consideration the potential uplift forces in a major unique storm event. (Areas neighboring Hopkinton have indeed experienced more than one actual tornado in recent years, and at least one barn roof was lost.)

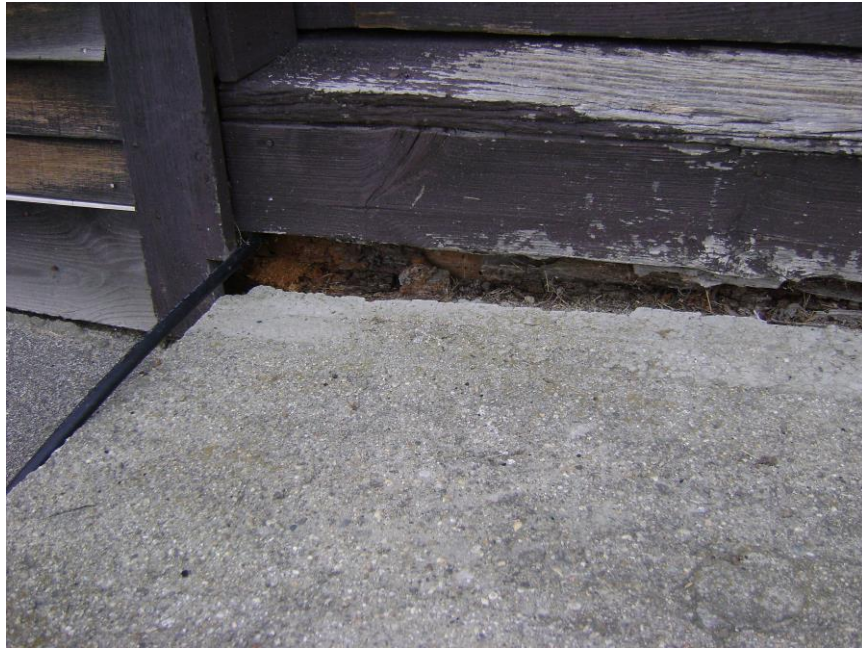
The barn generally has the considerable benefit of 'high and dry' siting. However at the south door concrete steps, blacktop, and landscaping details are in close contact with the barn frame at ground level, and likely directing rainwater into sill timber areas.

Photos #15 - Entry step fostering sill decay under southeast doorway.

The door threshold and sill areas should be fully accessed and investigated. Decayed timbers can be replaced or repaired if needed, and then very thoroughly protected with flashing and/or waterproof membranes, followed by re-grading for improved drainage.

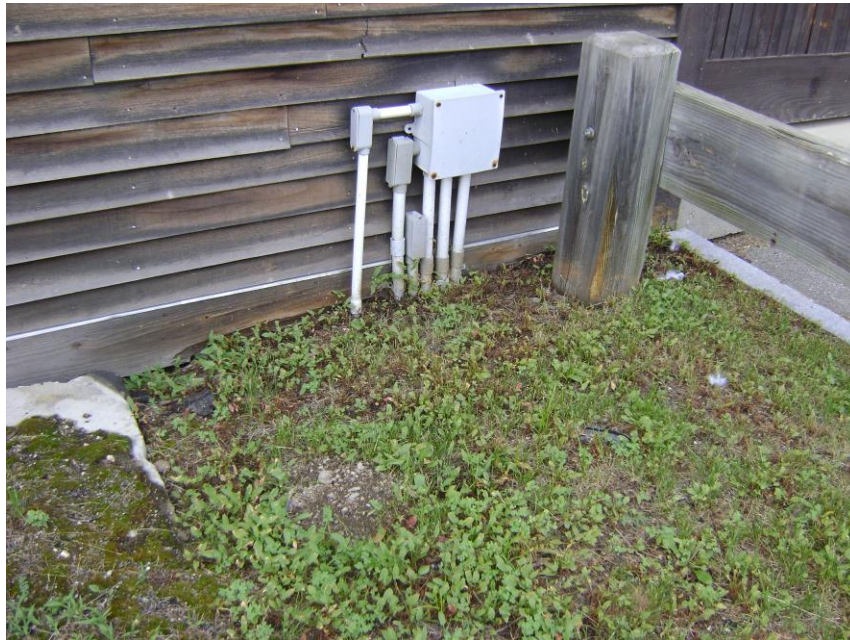
Photos #16 - Landscaping details (grade too high) fostering sill decay, south wall.

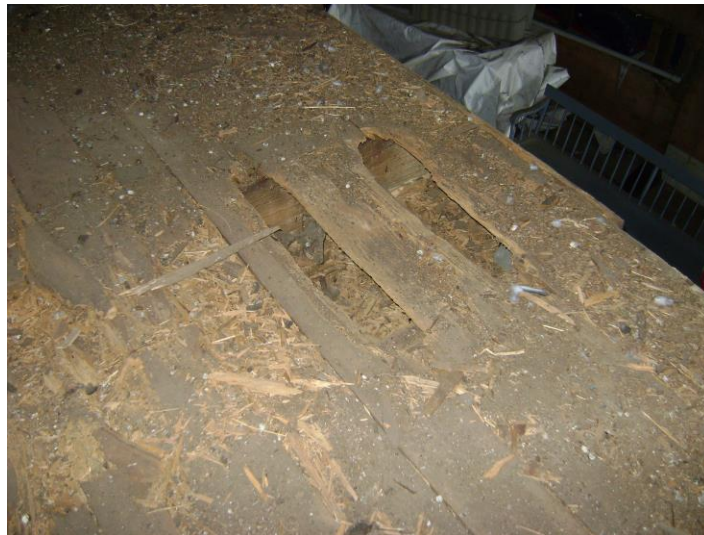
The primary loft floors are two layers of nominal one-inch boards, and generally sound. Limited areas, especially in the west side, are rotted and hazardous, probably from roof leaks in the past.

Photo #17- East loft, floor decay.

The loft flooring needs simple replacement in limited areas, prioritized with safety in mind. The high catwalks can be inspected and repaired if needed, but should be considered generally off-limits meanwhile.

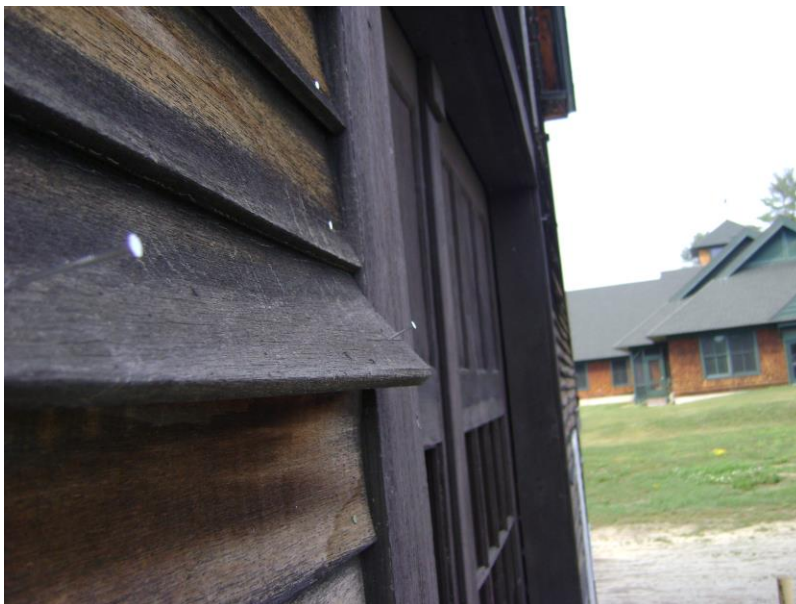
The modern clapboarding was obviously a great, even heroic, investment towards saving the Huston Barn and is aesthetically attractive. Very regrettably it is displaying some cupping and detachment in various widespread places, and the nails are pulling loose from the sheathing over large areas, the result of cyclical wood movement as weather acts upon the clapboards.

Photo #18 - Clapboards warped and detached, with nails pulled. Typical of many.

In this writer's opinion, the cupping and nail-pulling is the result of uneven wetting and drying (exacerbated by sun and wind) between the interior and exterior faces of the wood. This may be especially found in some modern clapboards that are largely lower quality face-grain, as opposed to traditionally quarter-sawn (edge-grain) premium siding which is far more stable.

Most importantly, it appears that the clapboards were not painted, oiled, or sealed in a way that would effectively retard uneven wetting and drying (possibly because of concern about "cedar bleeding" in fresh clapboards). However, painting, or preferably staining, them now would be of limited value. They are already warped and distorted, and the weathered surface will not hold coatings as well as fresh wood would have. A priming coat would be needed, at a minimum.

At a very minimum, the most cupped and warped clapboards could be individually replaced, or perhaps nailed back down in lesser cases. Loose nails that are "popping" through-out could be perhaps re-driven and the clapboards possibly tightened up. But it is most likely these measures would be only partially successful, and temporary. The same issues would recur for the same reasons.

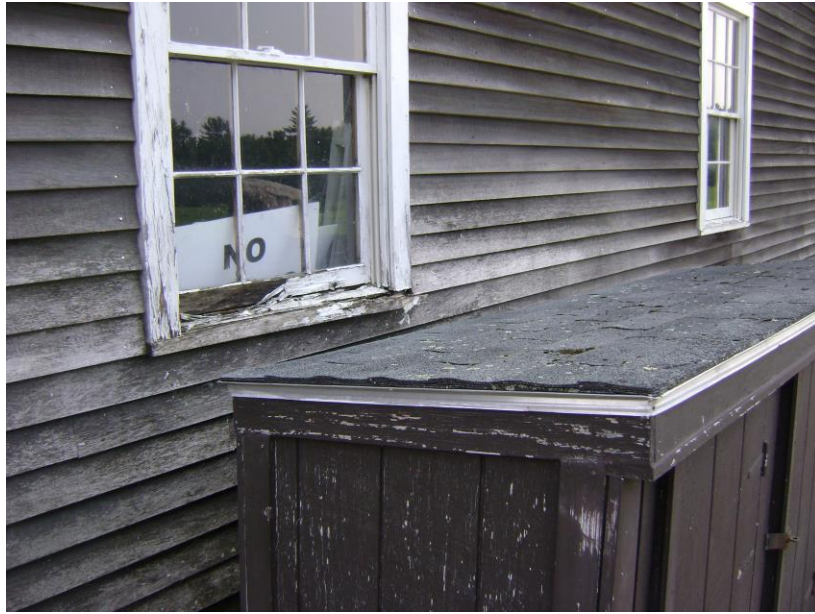
Photo #19 - Water damage to window resulting from proximity of bin assembly.

Trim can be repaired as needed in limited areas, such as the corner board by the southeast cow door. A carpenter-built set of bins at the south end of the east wall is splashing roof water back onto the siding and skirt-board, causing decay, and has ruined the window casing there. The bins should be re-located and the casing replaced.

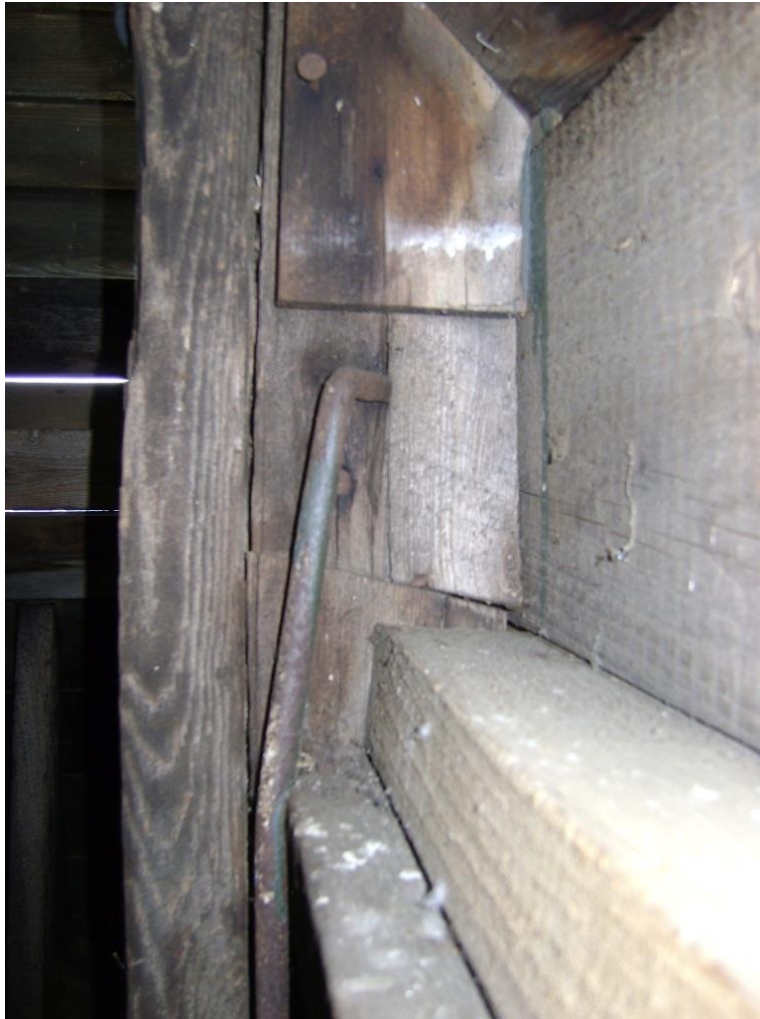
When it was reduced in height, long iron staples were driven to secure the sawed off posts at roof level, and they have served. But their performance in an extreme weather event might be pondered.

Photo #21 - Interior of Cupola, showing iron staple anchoring cut post. (Typical)
